Experimental and analytical investigation of dynamic crack patterns in automotive windshield sheets subjected to low velocity impact

Abstract

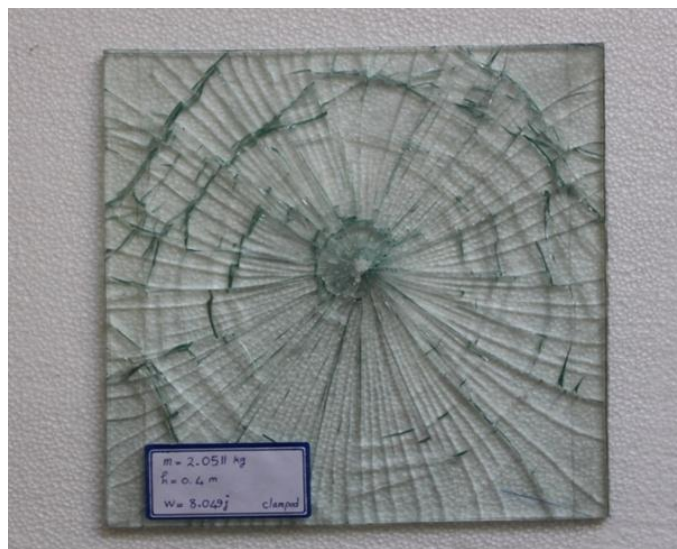
Fig10. .specimen after test code D-B-T-4

Laminated glass specimen after test code D-B-T-4 is shown in Fig.10.

As it is observed from Fig.10, the impact region at the center of specimen (powdering region) is a circle with approximate diameter of 20mm in which cracks density and consequently damage level is higher than the other regions of specimen. The projectile has penetrated to the depth of 1-1.5mm of the laminated glass and due to 2.5mm thickness of glass layers, no elongation has been occurred in PVB interlayer. Although energy level of test code D-B-T-4 is higher than test code D-B-T-3's one, penetration at the center of specimen is less in test code D-B-T-4 which

can be representative of impactor's mass influence. In test code D-B-T-4, the impactor mass is 2.0511kg, while it is 2.0712kg in test code D-B-T-3, therefore it can be concluded that in 2 similar conditions, the less impactor mass, the less penetration depth at the center of specimen.

It is easily seen from test code D-B-T-4 specimen that cracks have initiated from the impact surface and propagated through thickness. In this test, one circumferential crack has been propagated which is at the radius of 95mm from the center. Besides, some sectors of circumferential cracks have been made at the

radiuses of 62, 70 and 80mm from the center of specimen and serve as bridges to connect radial cracks. Also it can be seen from the laminated glass that the radial cracks in test code D-B-T-4 are nearly symmetrical and about 84. After drawing a comparison between test code D-B-T-4 and test code D-B-T-3, it is obvious that radial cracks of test code D-B-T-4 are more than their counterparts in test code test code D-B-T-3, on the other hand circumferential cracks of test code D-B-T-3 are more than test code D-B-T-3's ones. At test code D-B-T-4, distance between radial cracks is shorter than its corresponding item in test code D-B-T-3.

At all 4 sides of specimen which was clamped during the test, diagonal asymmetrical

net shaped cracks have been made which have created some right triangles in margins of the specimen. Diagonal net shaped cracks at the margins of test code D-B-T-4 specimen are more congested in comparison to the whole radial cracks. In addition, at both upper and lower glass layers, radial cracks converge at the center of the specimen and their divergence increases at larger radiuses. The acceleration versus time graph of test code D-B-T-3 is illustrated in Fig.11. As it can be seen from the graph, the maximum acceleration imposed to projectile is 732.0356 m/s^2 which is occurred at 0.000131 s .
